A short guide for the solution of the LPDA antenna's malfunctioning

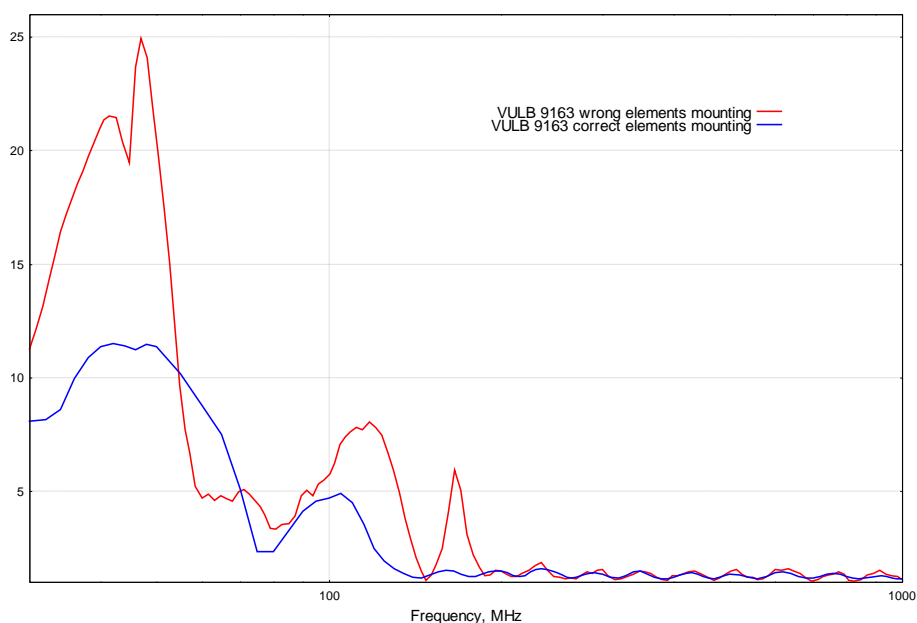
PROBLEM 1: If the antenna's elements have been mounted in a wrong way, e.g. after shipment, the VSWR of the antenna can be strongly affected, showing unexpected characteristics (peaks, differences with respect to the expected data, etc) as shown in the following plot.

SOLUTION: We suggest to check the mounting of the elements and to be sure that they satisfy the mounting “zig-zag” scheme showed in the following figures (Left figure: side view, Right figure: front view).

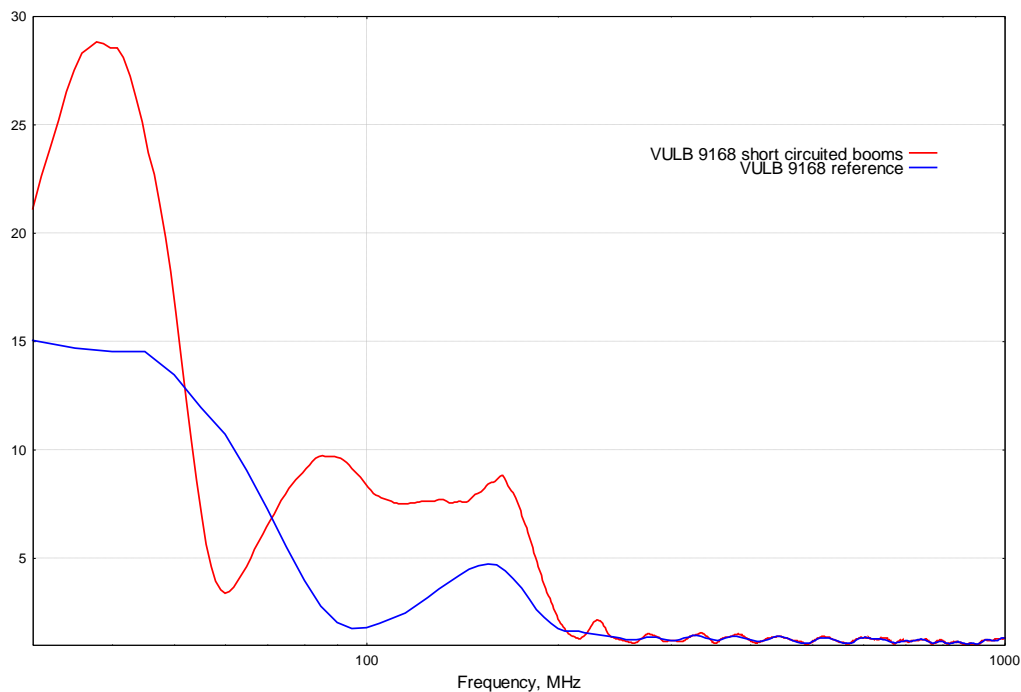
PROBLEM 2: untypical shapes of the VSWR can be caused when the antenna's booms are short-circuited (for example by a conductive label), as shown in the following plot:

SOLUTION: remove the conductive materials (aluminium or copper labels, etc.) between the two booms of the antenna.

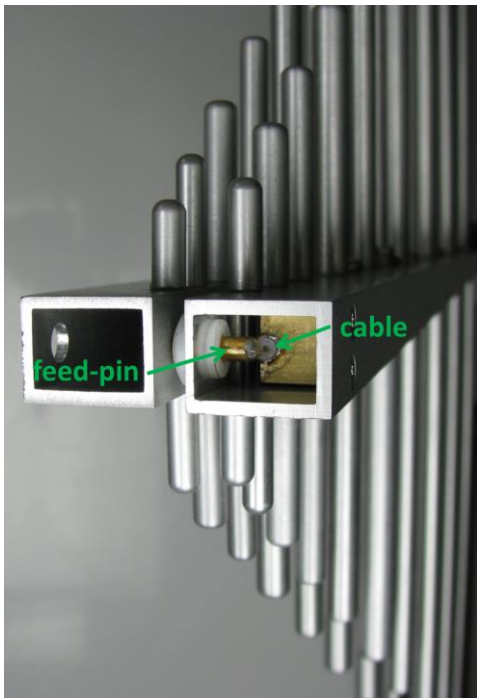
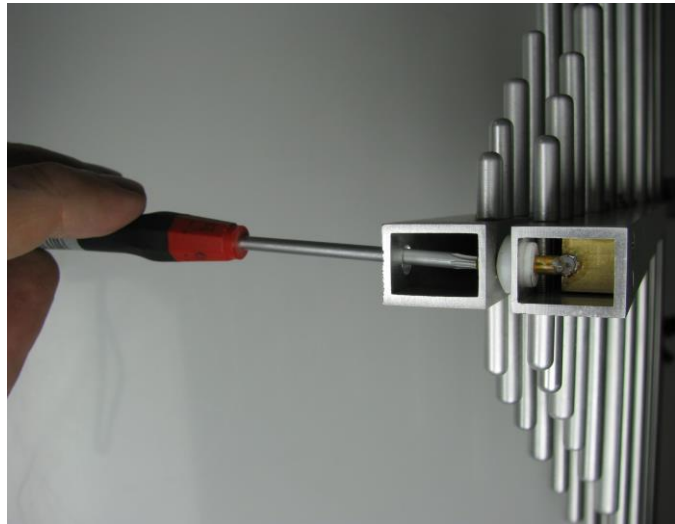
PROBLEM 3: the antenna is showing receiving-problems.

SOLUTION: if the connection between the coaxial cable and feed-pin indicated by the green arrows in the following left figure is getting loose, they should be re-soldered, using a common solder with temperature between 350-400 °C. Pay attention not to damage or to overheat the cable. Another possible cause could be related to a loosening of the feed-pin screw. To solve this problem remove the round plastic cap on the boom and use the appropriate screwdriver to tighten the screw, as shown in the following right figure.

SUGGESTION: no force should be applied to the two booms of the antenna. If they are pressed together the tip parts move away and the connection may get damaged.
