A short guide for the solution of the LPDA antenna's malfunctioning

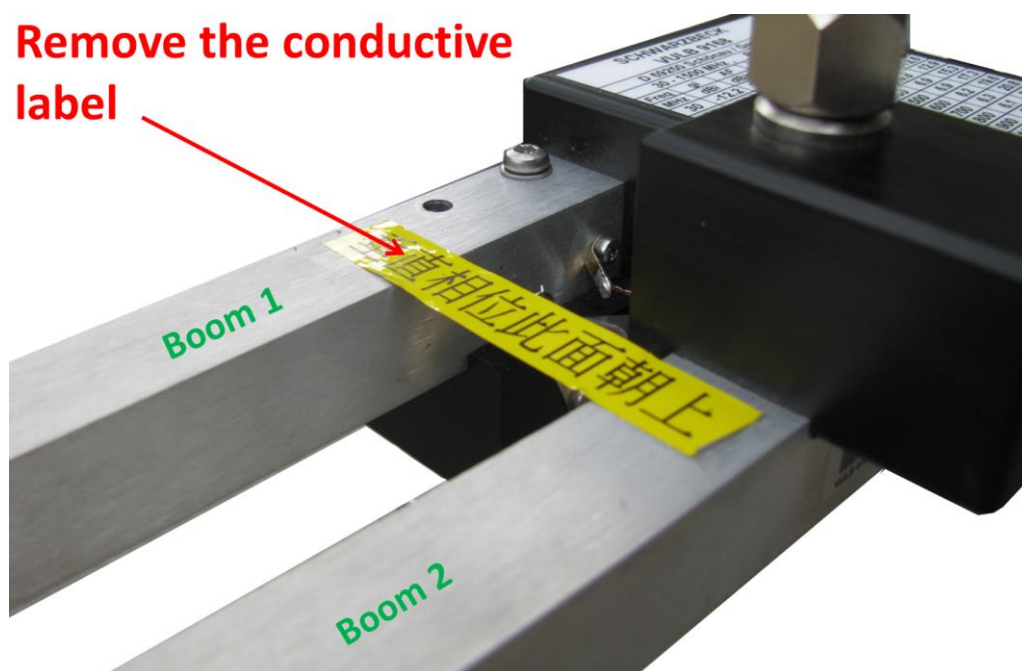
PROBLEM 2: untypical shapes of the VSWR can be caused when the antenna's booms are short-circuited (for example by a conductive label), as shown in the following plot:

SOLUTION: remove the conductive materials (aluminium or copper labels, etc.) between the two booms of the antenna.
